RE: Construction Inspection Report for the Courtenay Wind Farm Project

Construction Inspection Report

Site Visit: April 6, 2016

200 MW Courtenay Wind Farm – Northern States Power Company – Stutsman County – PSC Case No. PU-13-064, PU-15-174

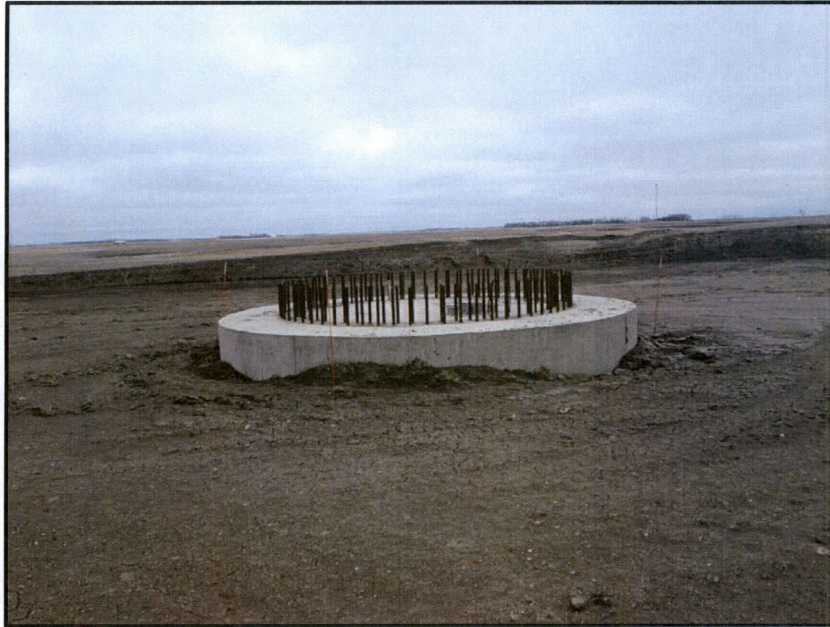
- Typical site layout, the turbine foundation is near the center of the excavated pad area with topsoil on outer edges (Photo #1, Point #149);
- Only part of the topsoil was replaced at this location. Note remaining topsoil pile to the right of photo. Topsoil will be stripped again in May to continue construction at this location (Photo #2, Point #150);

Photo 1. Tower 81 (GPS Point #149). Typical site layout, the turbine foundation is near the center of the excavated pad area with topsoil on outer edges.

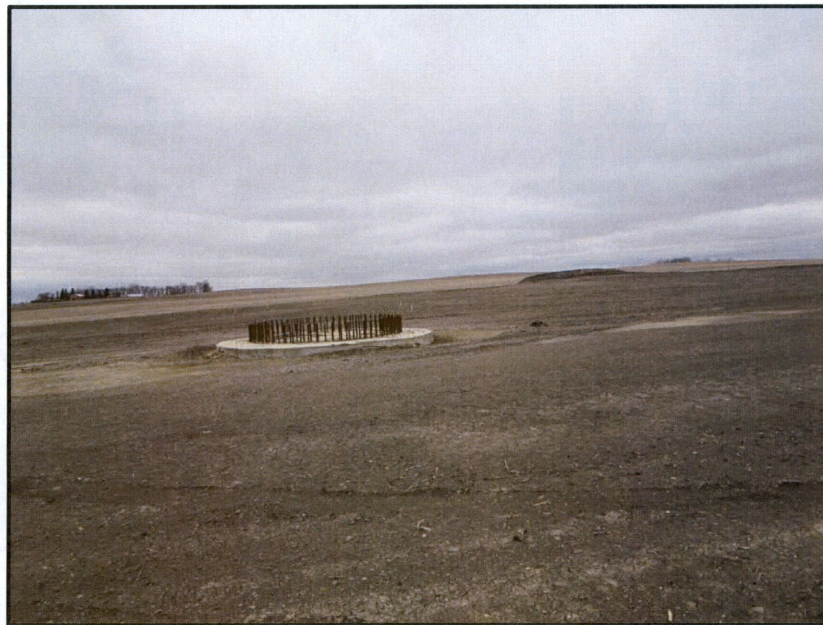
Photo 2. Tower 78 (GPS Point #150). Only part of the topsoil was replaced at this location. Note remaining topsoil pile to the right of photo. Topsoil will be stripped again in May to continue construction at this location.

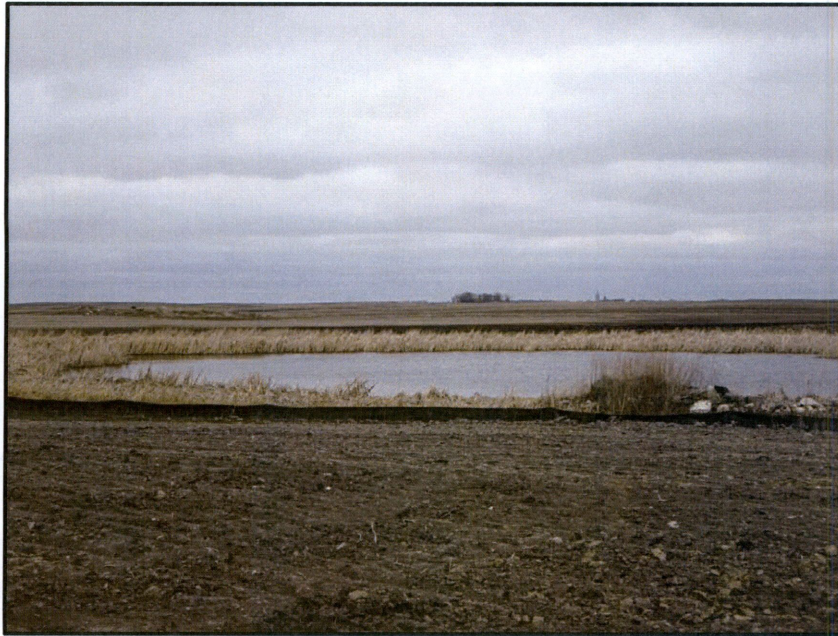
- Silt fence along edge of farmland between wetland and pad area, functional and in good condition (Photo #3, Point #151);
- Topsoil was replaced in this area, there are some uneven contours near the edge of the pad area by the corn field, but topsoil will need to be stripped again in this area for construction in May (Photo #4, Point #152);

Photo 3. Tower 84 (GPS Point #151). Silt fence along edge of farmland between wetland and pad area, functional and in good condition.

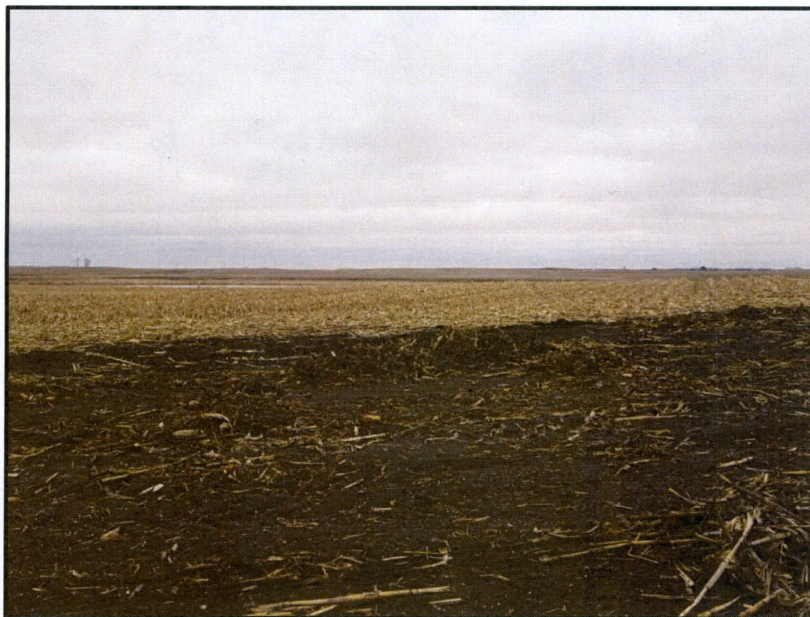
Photo 4. (GPS Point #152). Topsoil was replaced in this area, there are some uneven contours near the edge of the pad area by the corn field, but topsoil will need to be stripped again in this area for construction in May.

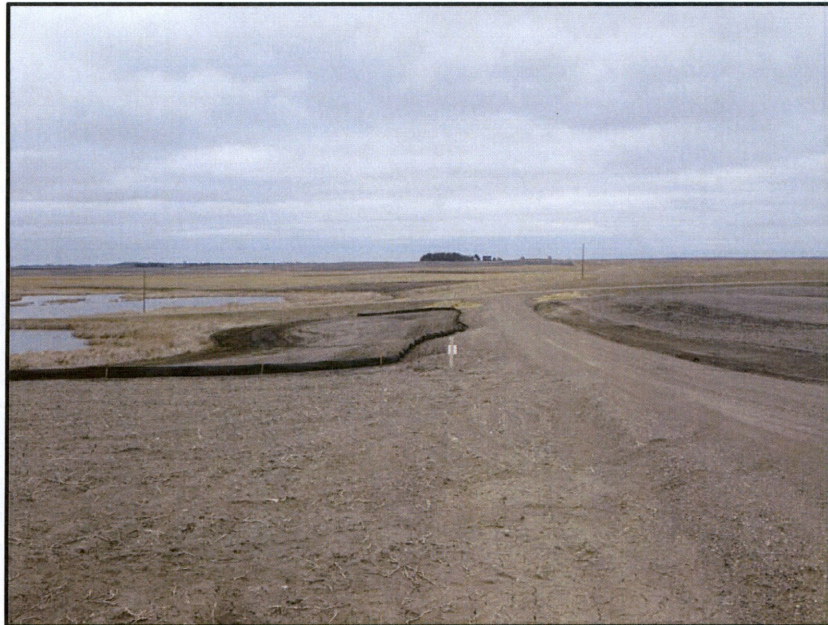
- Silt fence along access road and pad location (Photo #5, Point #153);
- Typical culvert and approach for access road. Straw wattles along culvert and ditch. Much of the mulch has blown away over the winter (Photo #6, Point #154);

Photo 5. Tower 98 (GPS Point #153). Silt fence along access road and pad location, functional and in good condition.

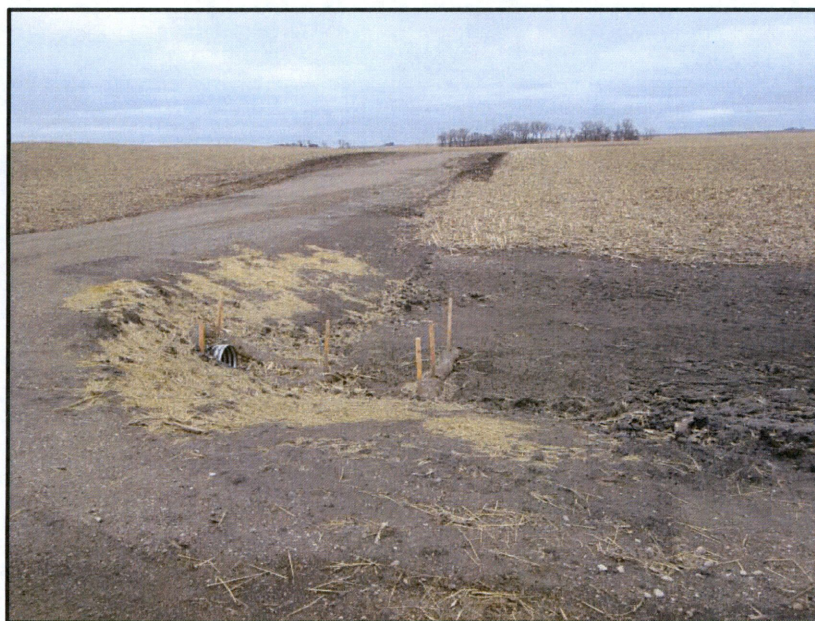
Photo 6. Near Tower 99 (GPS Point #154). Typical culvert and approach for access road. Straw wattles along culvert and ditch. Much of the mulch has blown away over the winter.

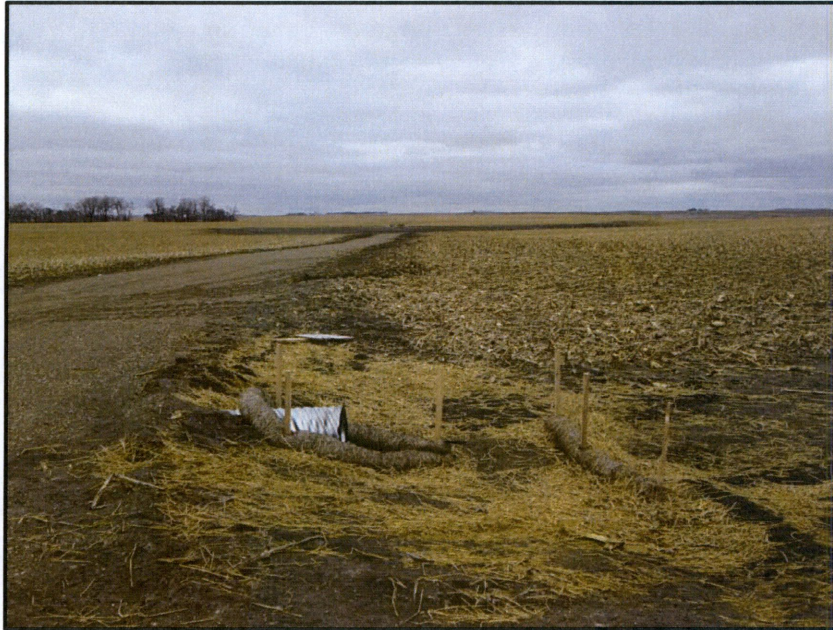
- Installed access road with culvert. Straw wattles along culvert and ditch, appeared to be functional and in good condition (Photo #7, Point #155);
- Typical pad location. Topsoil around the edges of site, with open area in the topsoil pile (right side of the photo) for drainage to prevent ponding water (Photo #8, Point #156);

Photo 7. Near Tower 100 (GPS Point #155). Installed access road with culvert. Straw wattles along culvert and ditch, appeared to be functional and in good condition.

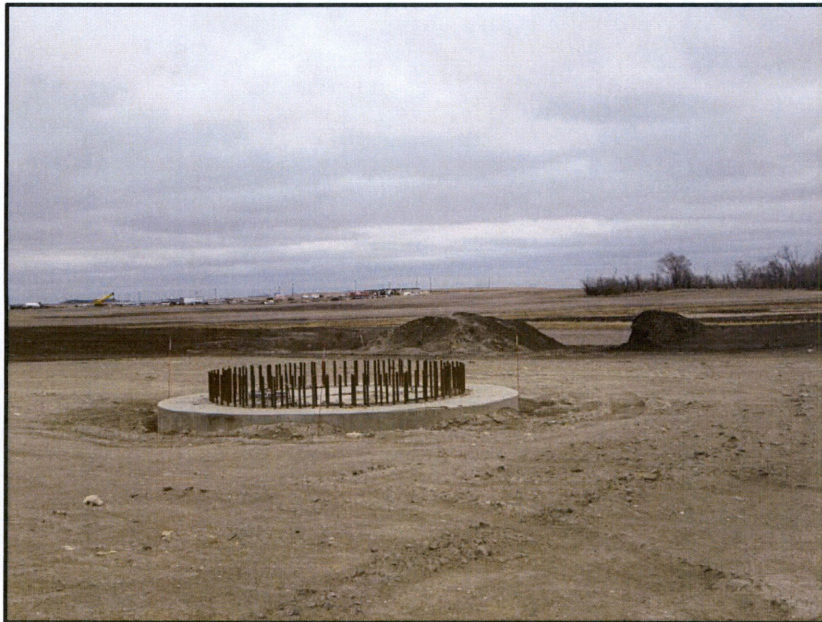
Photo 8. Tower 67 (GPS Point #156). Typical pad location. Topsoil around the edges of site, with open area in the topsoil pile (right side of the photo) for drainage to prevent ponding water.

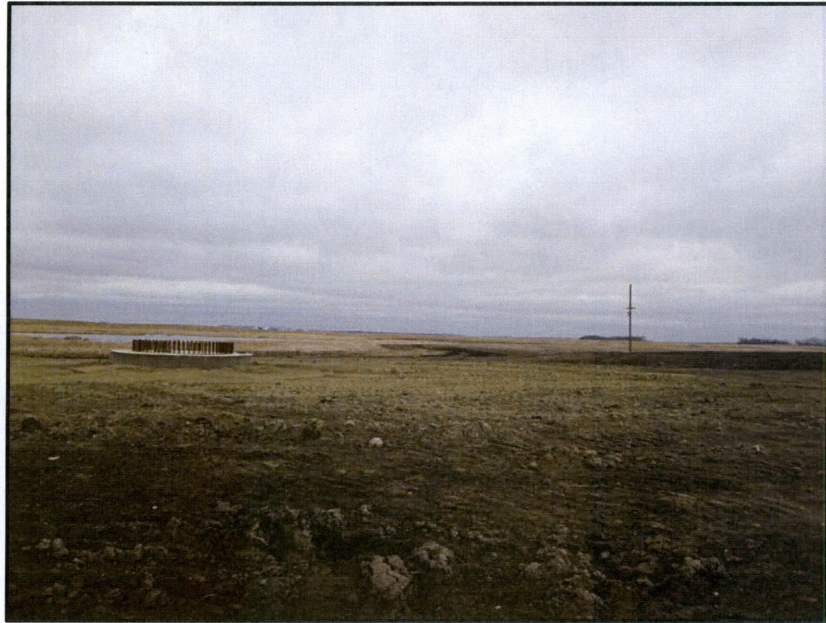
- Turbine foundation to the left of photo, topsoil pile along edge of pad area (Photo #9, Point #157);
- Foundation to the right of photo, topsoil pile along the edges of the pad (Photo #10, Point #158);

Photo 9. Tower 62 (GPS Point #157). Turbine foundation to the left of photo, topsoil pile along edge of pad area.

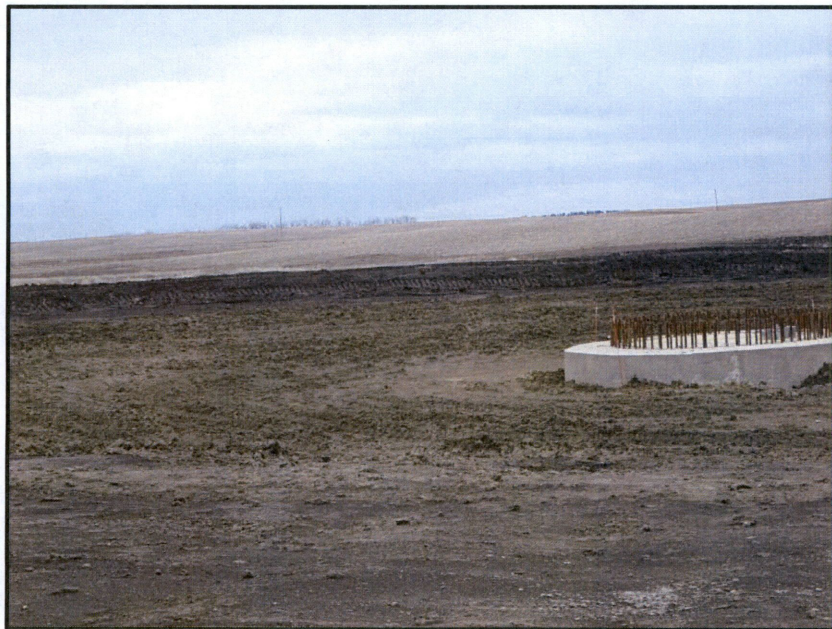
Photo 10. Tower 60 (GPS Point #158). Foundation to the right of photo, topsoil pile along the edges of the pad.

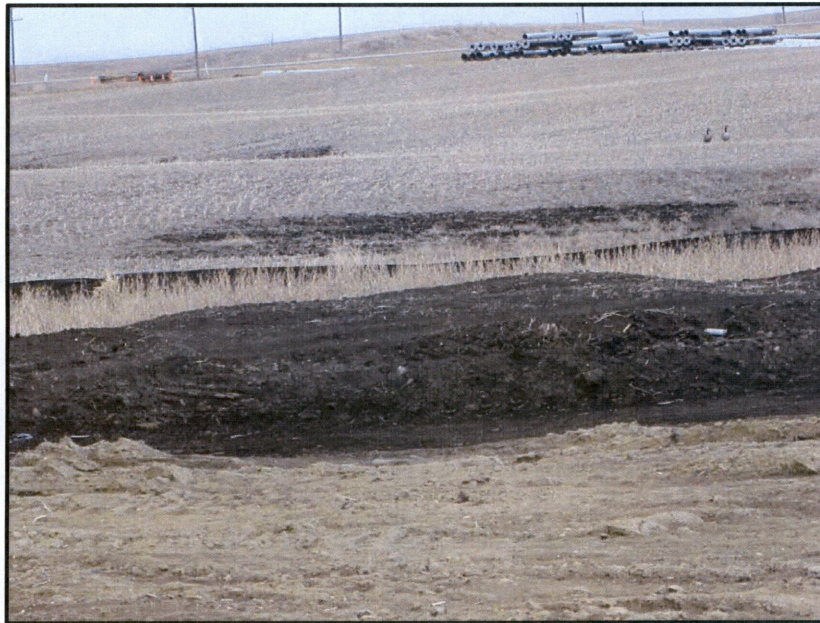
- Topsoil pile along edges of pad, silt fence behind topsoil piles to prevent sediment migration to wetland to the right of the turbine location (not visible in photo) (Photo #11, Point #159);

Photo 11. Tower 61 (GPS Point #159). Topsoil pile along edges of pad, silt fence behind topsoil piles to prevent sediment migration to wetland to the right of photo and the turbine location (not visible in photo).

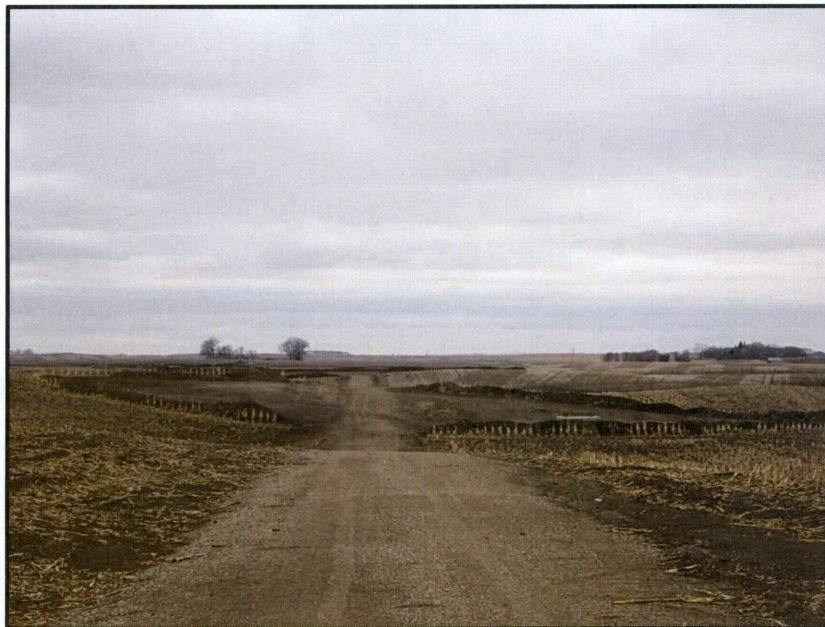
- Access road connecting wind turbine pads, foundation to the right of photo, topsoil along edges of pad (Photo #12, Point #160);
- Typical site area. Topsoil around the edges of site, open area in the topsoil pile (right side of the photo) for drainage and ponding water (Photo #13, Point #161);

Photo 12. Tower 45 (GPS Point #160). Access road connecting wind turbine pads, foundation to the right of photo, topsoil along edges of pad.

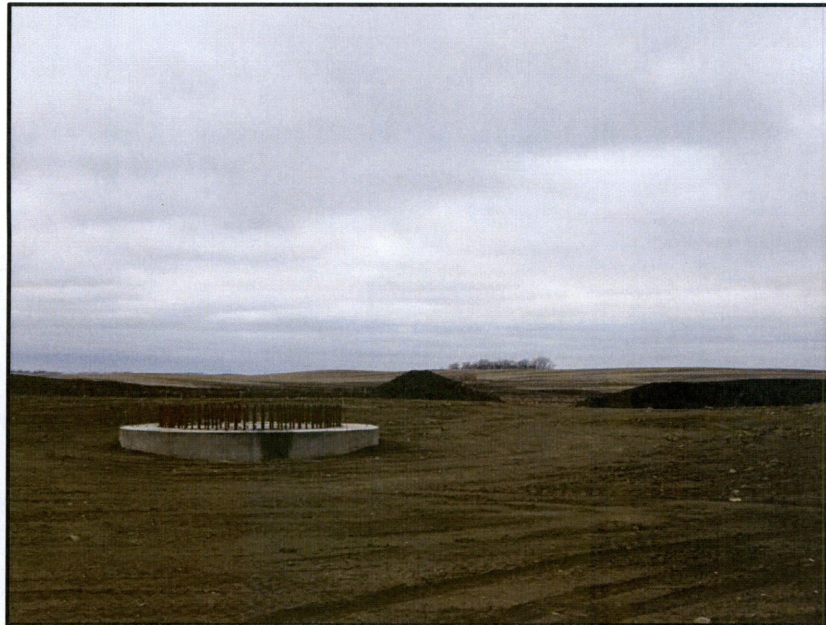
Photo 13. Tower 44 (GPS Point #161). Typical site area. Topsoil around the edges of site, open area in the topsoil pile (right side of the photo) for drainage and ponding water.

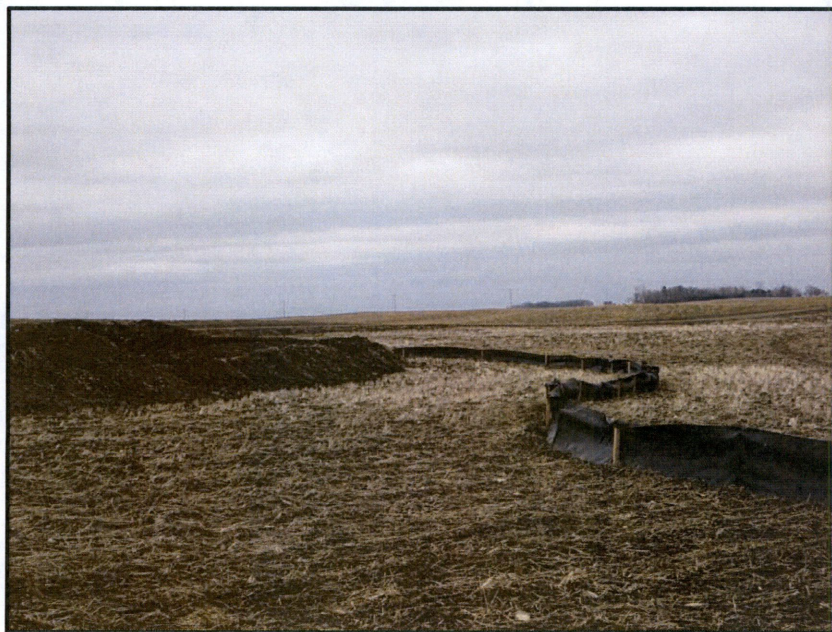
- Topsoil pile to the left of photo, and silt fence to the right of photo on downslope in farmland (Photo #14, Point #161).

Photo 14. Near Tower 44 & 45 (GPS Point #161). Topsoil pile to the left of photo, and silt fence to the right of photo on downslope in farmland.
